Are You Seeing These Problems?

Piston ring dowel pin migration

Engine: 1993 & up carbureted 185/200/225/250 HP Evinrude & Johnson Outboards (90 degree closed deck loopers)

Internal water cavity leaking into #1 cylinder.

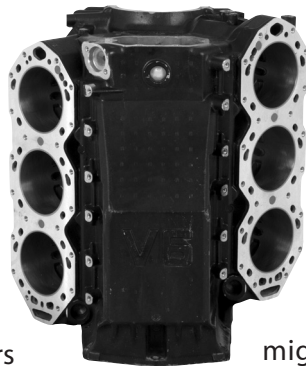
Description: Approximately 70% of the 90 degree closed-deck loopers we receive for machine work need repair because of piston ring dowel pin migration. This typically occurs when cylinder/piston temperatures are sustained at slightly over their threshold for extended running periods. As a result, the aluminum piston *lets go* of the steel dowel pin in the top ring groove. The pin will usually leave a notch or groove above the corresponding fingerport in the sleeve. In several cases, exhaust port damage will result from the top ring trying to exit out the exhaust port. This occurs when the dowel pin forces the top ring gap open while the pin is exiting the piston. Re-sleeving is required in 80% of these occurrences.

Cause: The cause of *dowel pin migration* in these cases is not a defective piston, but a lack

of water (coolant) in particular areas of the block, resulting in elevated temperatures in the cylinder/ piston.

Repair and results – closed-deck cooling modification: By modifying the cooling passages around the cylinders, dowel pin migration has been significantly improved. MarFab has been doing cooling modifications since mid-summer of 2001. We have had no returns with dowel pin migration thus far.

Note: The original OEM 1/4" red and/or white plastic water deflectors are removed and substituted as part of the cooling modification. The original deflectors **should not** be replaced.
